Experimental analysis of the shear transfer mechanism in a composite bridge beam manufactured from advanced polymer composites.

E. Gutiérrez, S. Primi

European Laboratory for Structural Assessment (ELSA)
I-21020 Ispra (VA), Italy

EUR 21549 EN

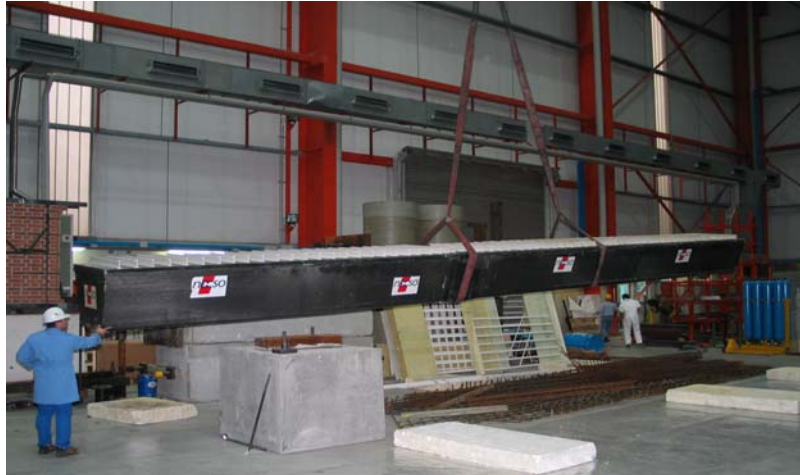
Figure 29 Carbon fibre beam.

The carbon-fibre sandwich beam can be seen in Figure 29 being manoeuvred into position prior to the placement of the GFRP slab formwork. The pultruded shear-lock connectors are shown in Figure 3 ,in Figure 4 we show how the slab formwork was put into place, and in Figure 30 the deck fitted with the reinforcing steel. The beam was mounted between two RC blocks in order to simulate the supports piers in the real bridge. During the pour no props were used to support the carbon fibre beam as it is designed to be stiff enough to carry the 17 tons weight of the poured concrete with only a 4 mm deflection. This highlights the advantage of using lightweight composites as self-sustaining formworks. However, restraints were used at either end of the deck in order to prevent rocking and overturning of the beam about its main axis. Such constraints was not required when the full bridge was assembled in the real work-site because the ends were prevented from twisting by the combined constraint generated by mounting the three beams side by side. Moreover, the ends were built in at the bridge abutments thus further preventing unwarranted displacements during pouring. Supports were provided in order to avoid permanent deformations in the overhangs of the RC deck, but the carbon fibre beam carried the main load at all times.

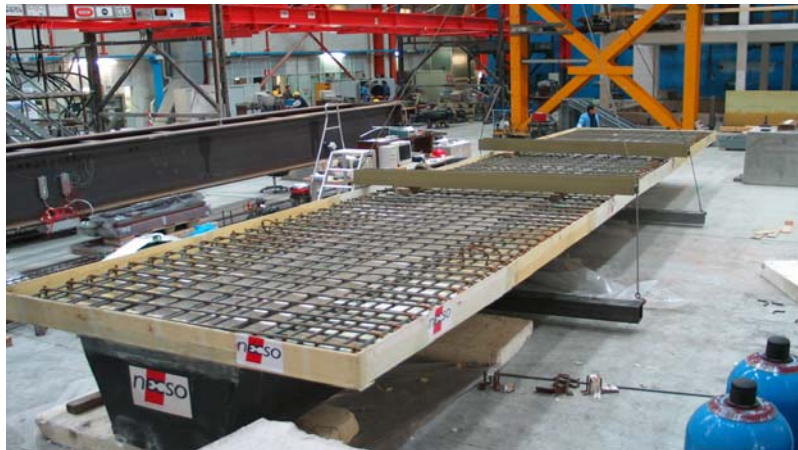
Figure 30 Reinforcement of RC deck.

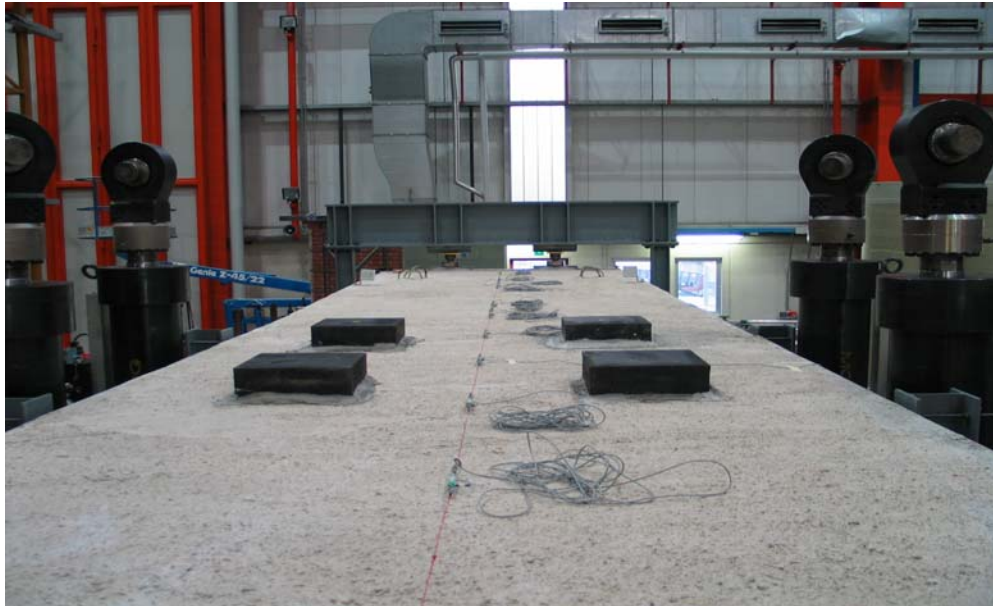
Figure 31 View of loading train steel-rubber bearings.
